**National Highway
Traffic Safety
Administration**

Case Vehicle (A): 1999 Dodge
 Type: Dakota Sport 4 x 2, Club cab 2-door pickup
 Driver: 76-year-old female
 CDC: 11-LYEW-2, 09-LBEW-1

Veh. (B): 1992 Ford
 Type: Ranger 4 x 2, pickup
 Driver: 32-year-old male
 CDC: 99-0000-0, 99-0000-0

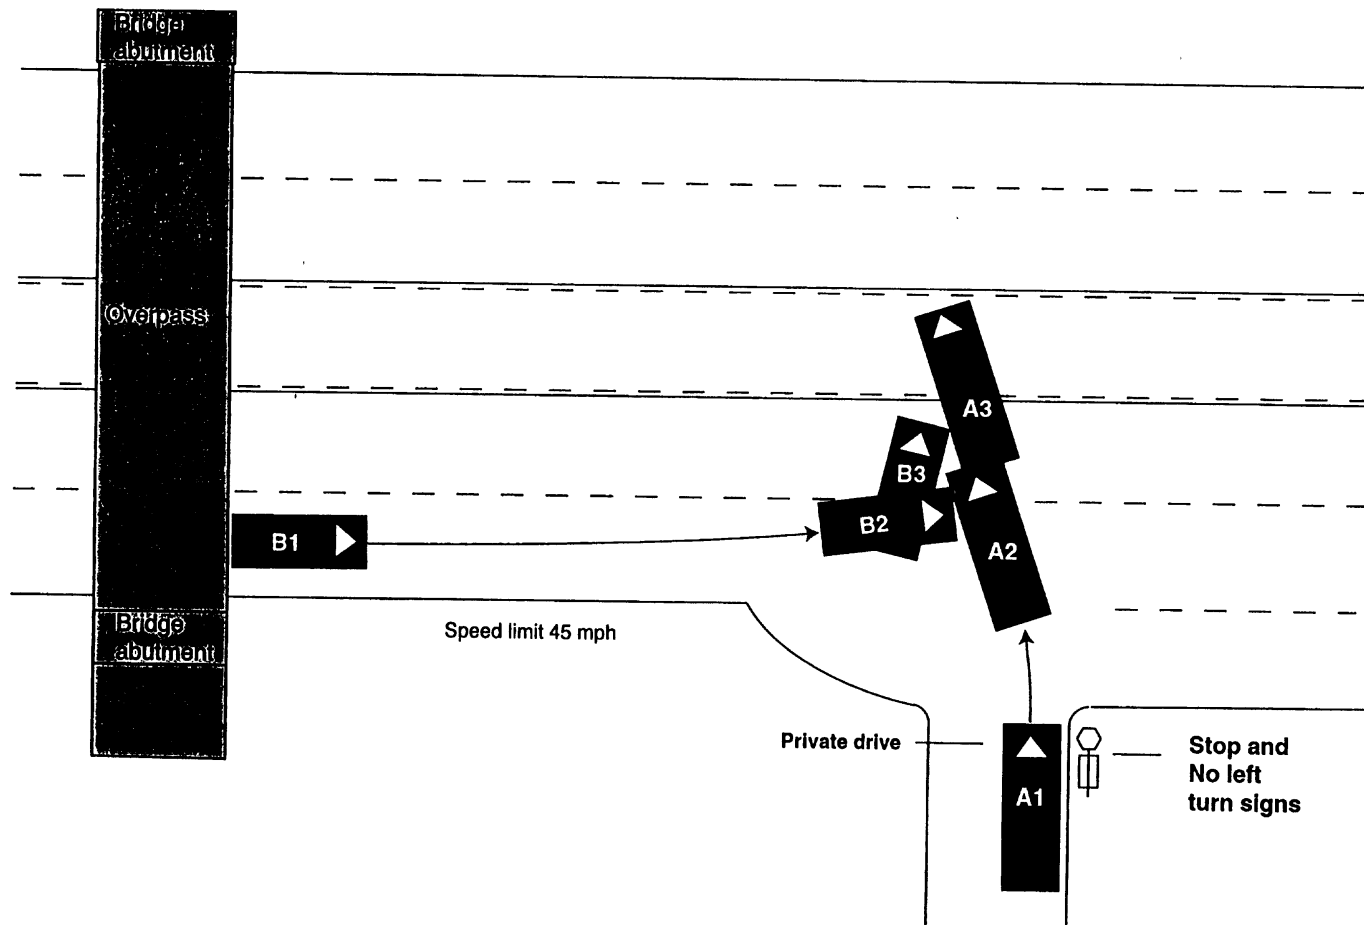
ACCIDENT SCHEMATIC

ACCIDENT DESCRIPTION: Case vehicle (A) was exiting a private
drive when it was struck on left side by
vehicle (B).

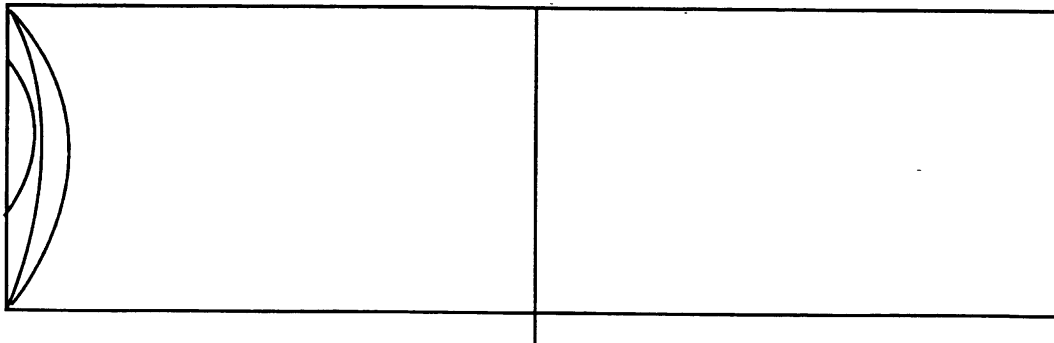
Cracked due to upper A-pillar deformation

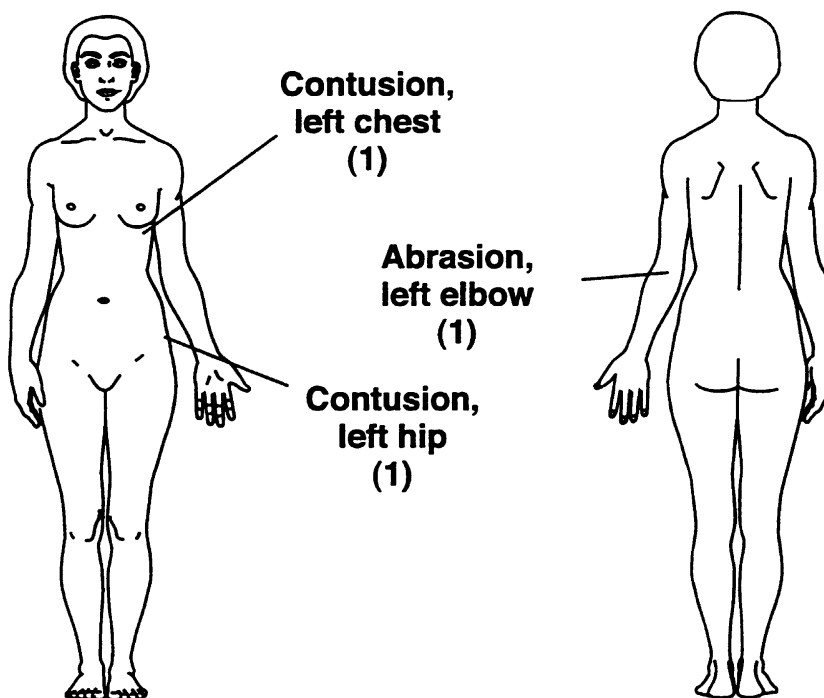
On impact, the driver moved forward and to the left relative to the vehicle interior into the belt restraint and airbag. She sustained a contusion to the left side of her chest, probably from direct contact with the side door interior panel, or possibly due to loading by the shoulder belt. She sustained an abrasion to her left elbow, probably from direct contact with the interior panel of the driver door, or possibly due to contact by the deploying airbag. She sustained a contusion to her left hip, probably from direct contact with the interior door panel, or possibly from loading by the lap belt. There were no witness marks on the (slide 39) driver-door window or the (slide 40) interior panel of the driver door.

Injury Description	A.I.S.	Injury Source		
		Definite	Probable	Possible
Contusion, left side of chest	1		Interior panel of driver door	Shoulder belt
Abrasion, left elbow	1		Interior panel of driver door	Airbag
Contusion, left hip	1		Interior panel of driver door	Lap belt
<u>Maximum A.I.S. Level</u>	<u>1</u>			
<u>Injury Severity Score</u>	<u>1</u>
